**ALABAMA
DEPARTMENT OF TRANSPORTATION**

**Subject: Annual Inspection Report
Prattville Municipal (Grouby Field) Airport**

**ANNUAL INSPECTION REPORT
PRATTVILLE MUNICIPAL (GROUBY FIELD) AIRPORT
PRATTVILLE, ALABAMA**

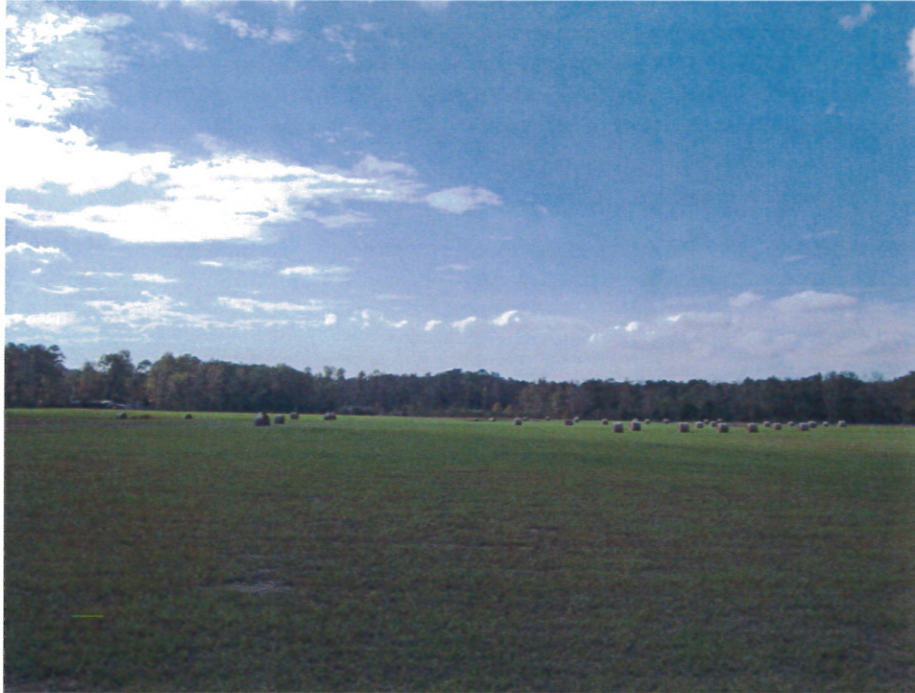
PHOTO 1

- The Approach and Departure Paths for runways 9 and 27 were inspected and found to meet state licensing standards.
- The FAA Runway Protection Zones of both runway ends is unobstructed.

Approach to Runway 9

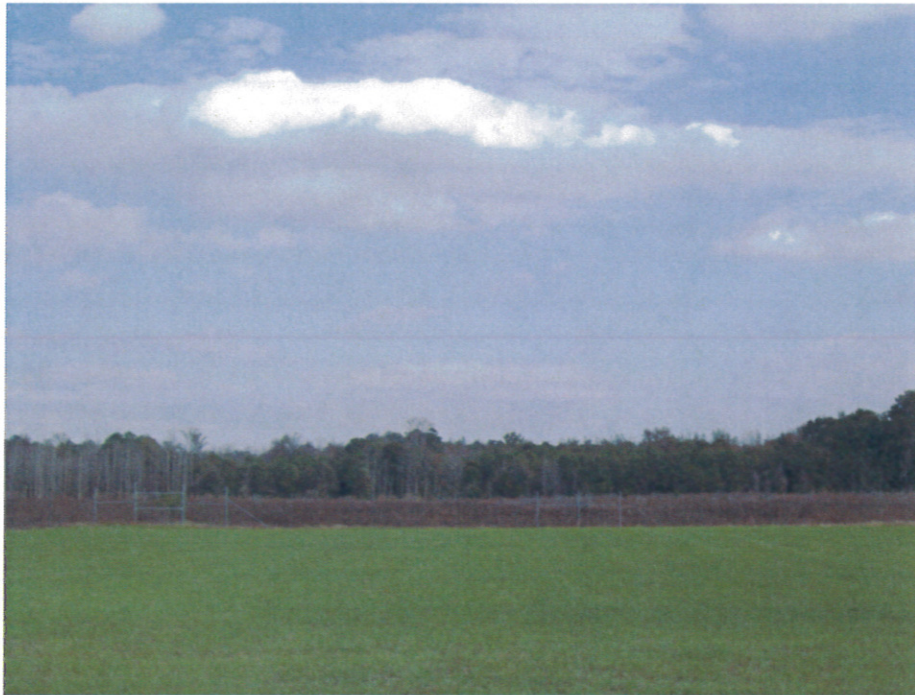
PHOTO 2

Approach to Runway 27

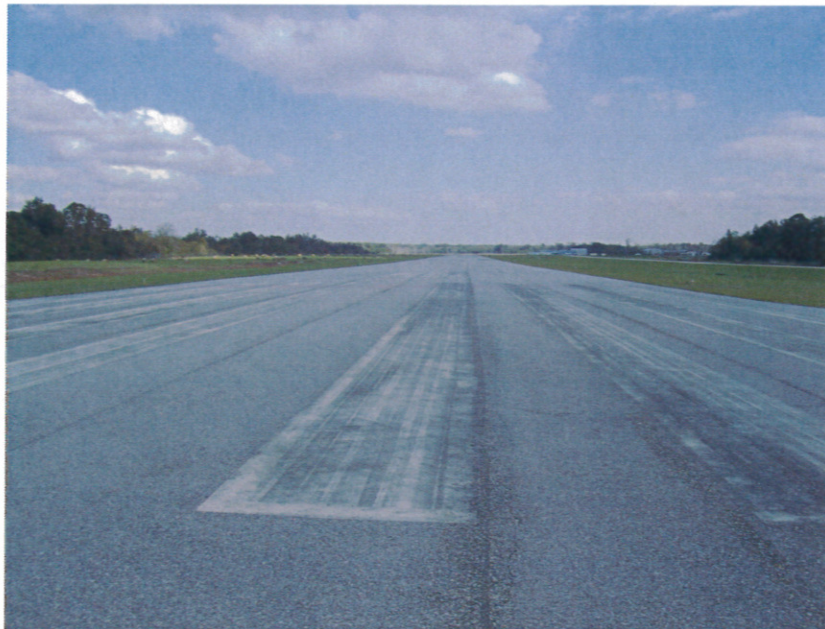
PHOTO 3

- The runway identifier markings of Runway 9 are in POOR condition.
- The runway identifier markings of Runway 27 are in POOR condition.
- The aiming bars of Runway 9 are in POOR condition.
- The aiming bars of Runway 27 are in POOR condition.
- The runway centerline is in POOR condition.

Runway 9 identifier markings in POOR condition

- Plans for the remarking of the runway should be formulated. The runway will need to be remarked in the near future.

Inspection Area	Violation/Maintenance	Corrective Action
Airport Markings	Maintenance	Remark runway in accordance with FAA AC150/5340-1J "Airport Markings"
Airport Lighting – PAPI unit of Runway 9	Maintenance	1. Adjust visual angle to provide a clear unobstructed path. NOTAM condition.

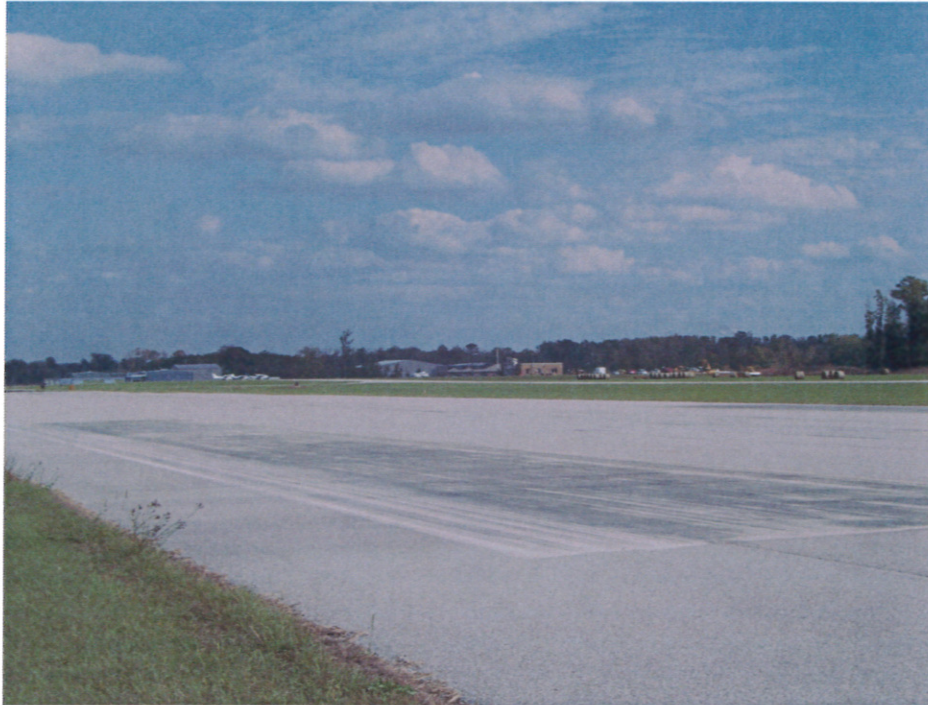
PHOTO 4

Runway 9 aiming point markings in POOR condition

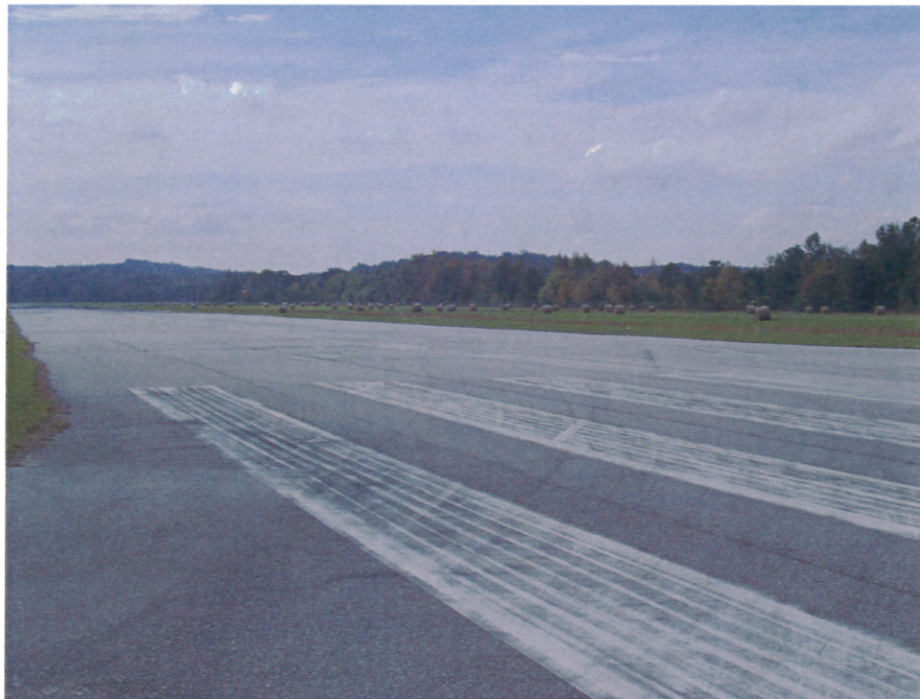
PHOTO 5

Runway 27 identifier markings in POOR condition

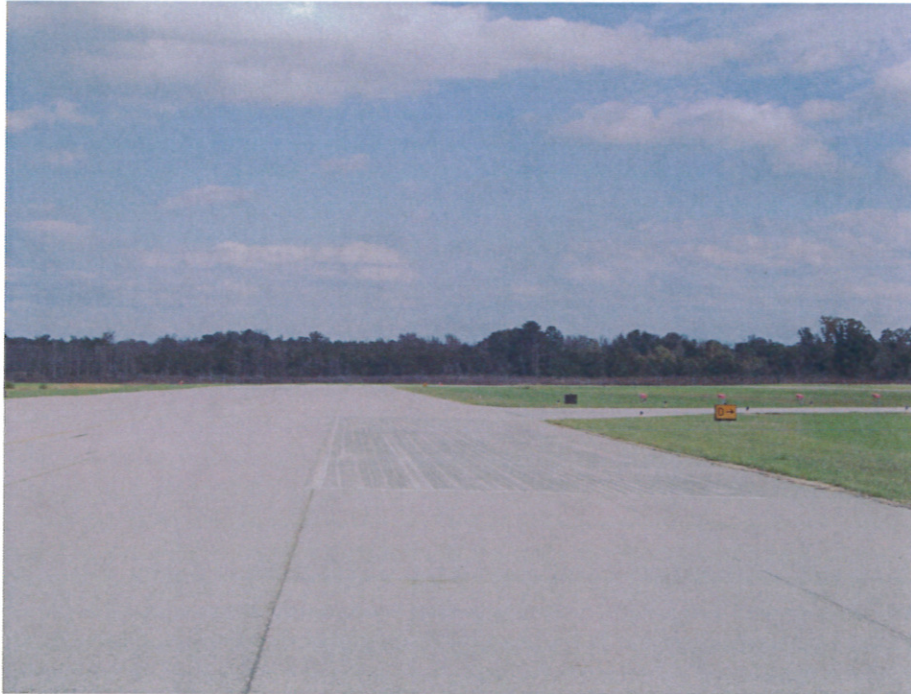
PHOTO 6

Runway 27 aiming bar in POOR condition

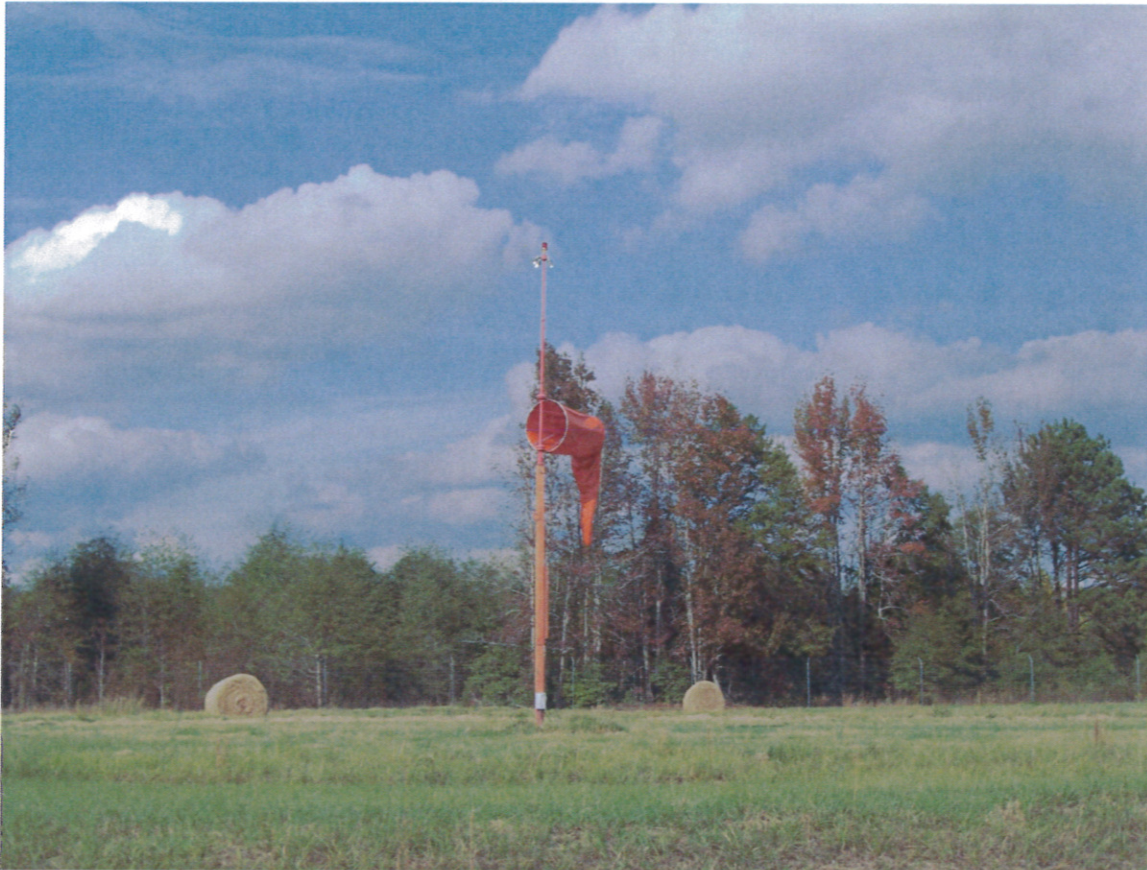
PHOTO 7

- ➔ The wind direction indicator (windsock) was operational.

Windsock Assembly

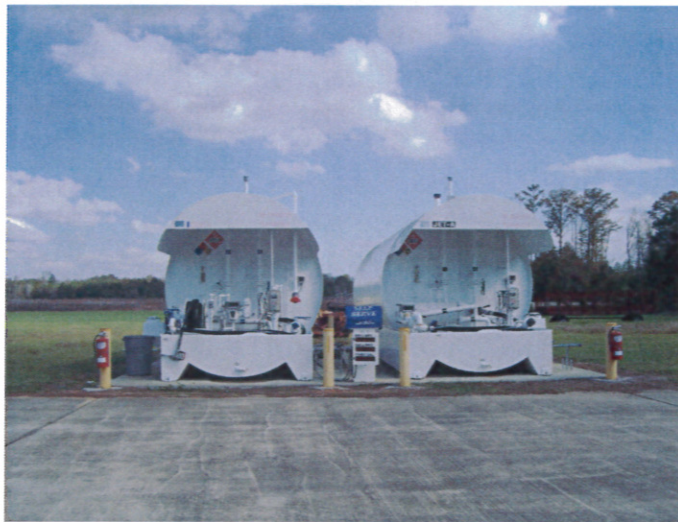
PHOTO 8

- The fueling area meets the requirements established by the Alabama Department of Transportation. However, the State of Alabama Department of Agriculture and Industries may have additional requirements for fueling systems that were not considered during this inspection.

Fuel tanks and card reader
